Informational Summary Report of Serious or Near Serious CAL FIRE Injuries, Illnesses and Accidents

GREEN SHEET

Dozer Rollover

Carr Incident

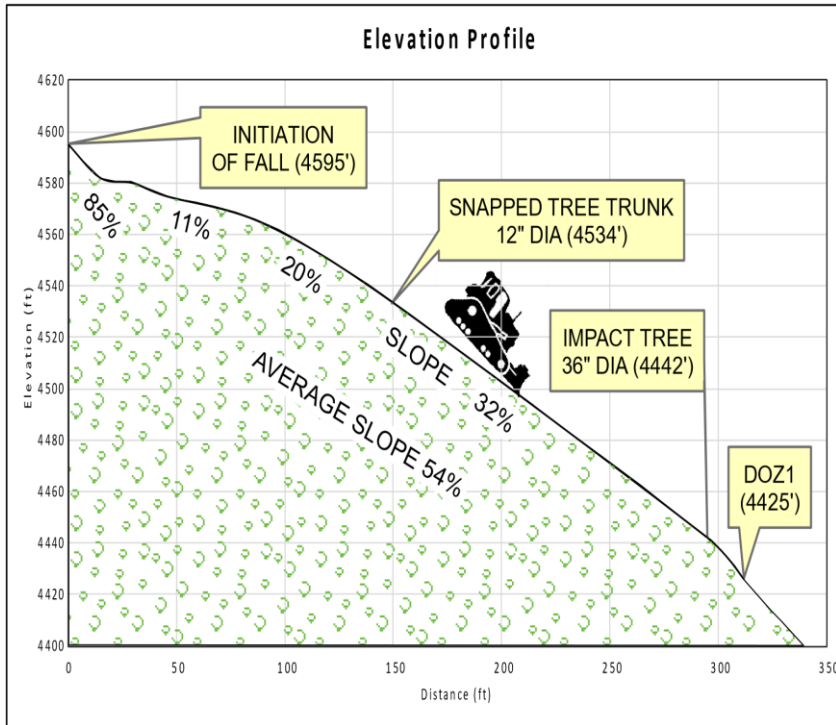
Elevation Profile

Vertical Drop: 169'
Horizontal Distance: 312'

Total Distance of Fall: 354'
Average Slope: 54%

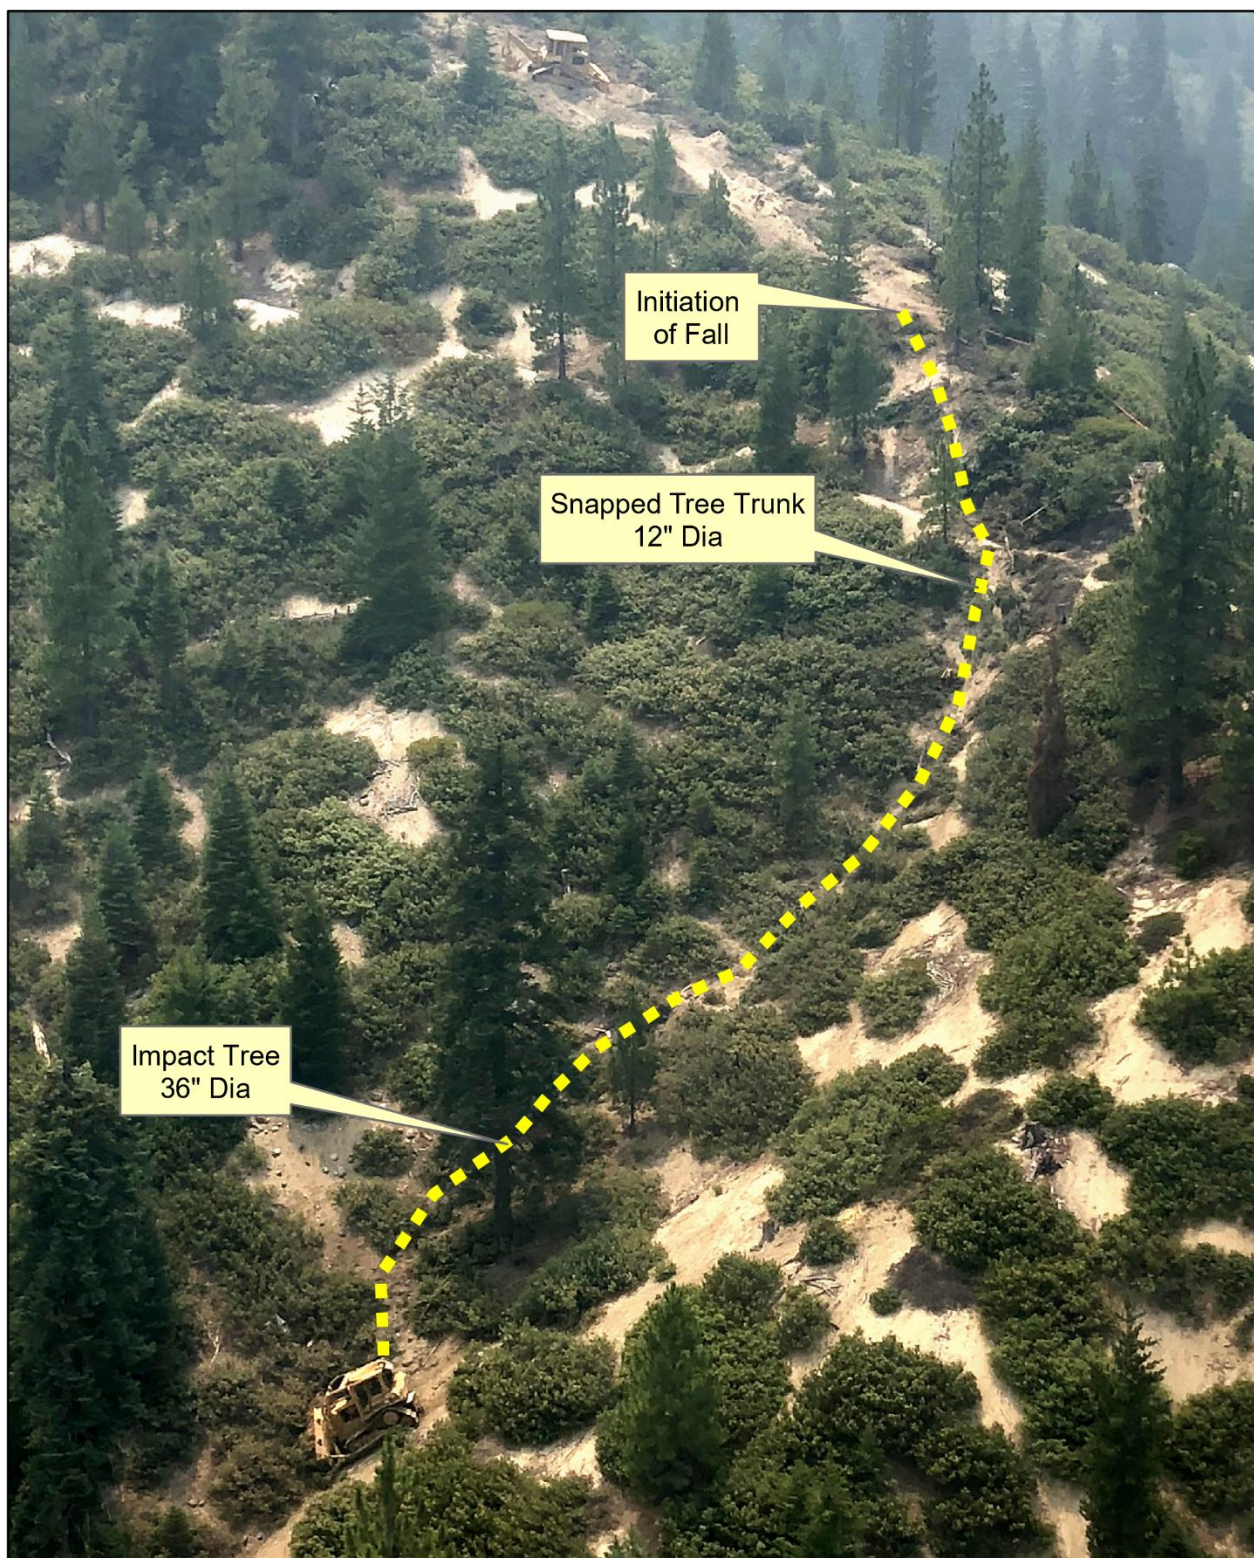
Path of Fall

The sudden backward motion of DOZ1 in combination with the increasing angle of the cut bank above the bench provided enough inertia to allow DOZ1 to pivot on its rear to a near vertical position and tumble end over end. DOZ1 then entered the top of a natural gully and turned sideways to the natural fall line, turning to the right and continue to roll several times snapping a 12" diameter pine tree approximately 100' below the ridgeline. DOZ1 then struck an approximately 36" diameter white fir tree, approximately 13 feet above the ground. DOZ1 momentarily caught on the tree, spinning it around approximately 290 degrees making it come to an upright stop 30 feet further downhill of the fir tree. The fir tree, located approximately 300 feet below the ridgeline, broke the chain of events preventing this accident from becoming a tragedy.

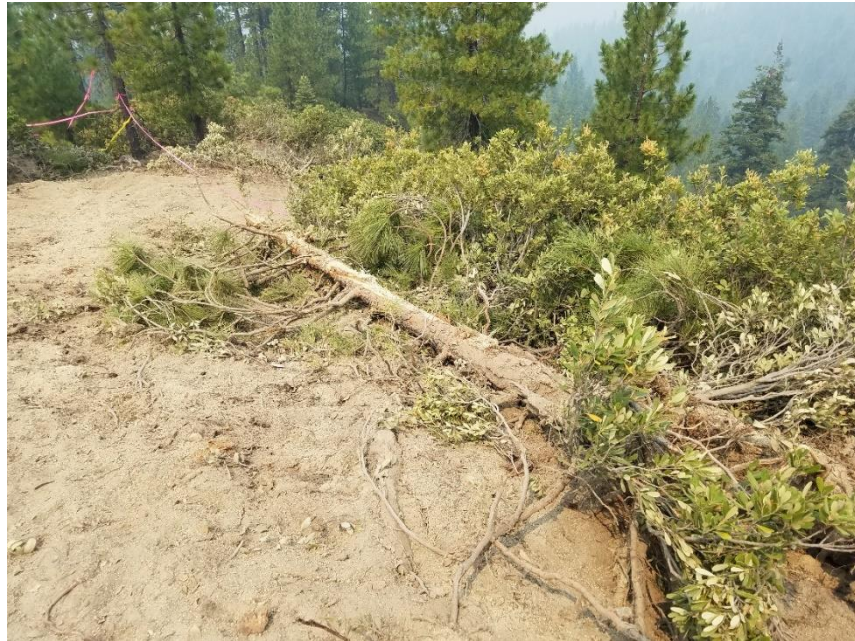
Field inspection of the site indicated the right side of DOZ1 encroached on the east edge of the ridgeline while constructing fireline. Vegetation material was crushed by the right tracks with the left tracks intermittently in contact with mineral soil and vegetation. The right tracks traversed a downed pine tree approximately 10" in diameter which was laying on additional vegetation. DOZ1 canted to the right as the tree and vegetation collapsed and the unstable soils underneath shifted. DOZ1 attempted to backtrack off the tree and vegetation, but abruptly slipped off the tree trunk rotating the front of the dozer to the left. The rear of DOZ1 was now downslope towards the drainage and the tracks perpendicular to the ridgeline. DOZ1 began to slide backwards towards the drainage in the sandy soil. The blade of DOZ1 rose up into the air as it slid down a short vertical cut bank and onto a small bench approximately 10' below.

Pine tree where incident originated. Resting on vegetation at edge of drop off.

Follow best work practices by keeping "dirt in the blade and tracks in the dirt". This practice allows a visual indication if the ground drops away from the blade, keeps vegetation from hiding terrain features, or causing the tracks to slip on vegetation.

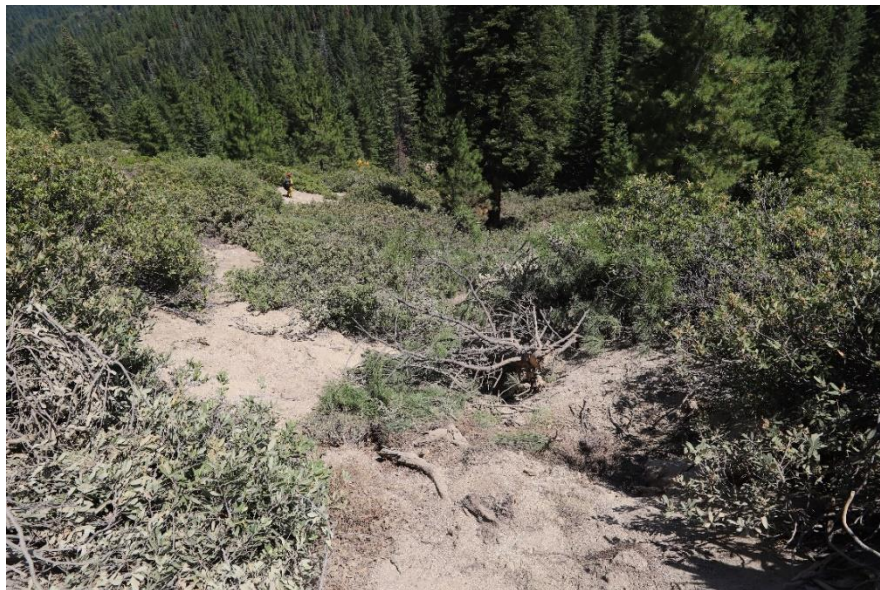
View east down fall line. Bulldozer is behind tree in center.

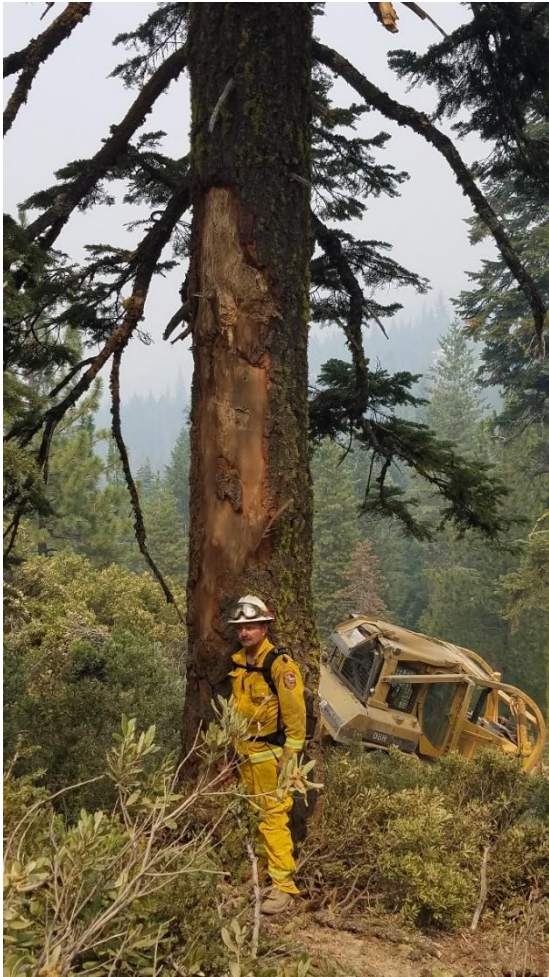
The force of impact from DOZ1 striking the fir tree broke the top of the tree. The left corner bit of DOZ1 blade was buried in the soil approximately 18 inches where it came to rest. OP1 inadvertently further stabilized DOZ1 by digging into the soft soil with the right track (uphill track) before shutting down.

Impact tree, DOZ1 in background

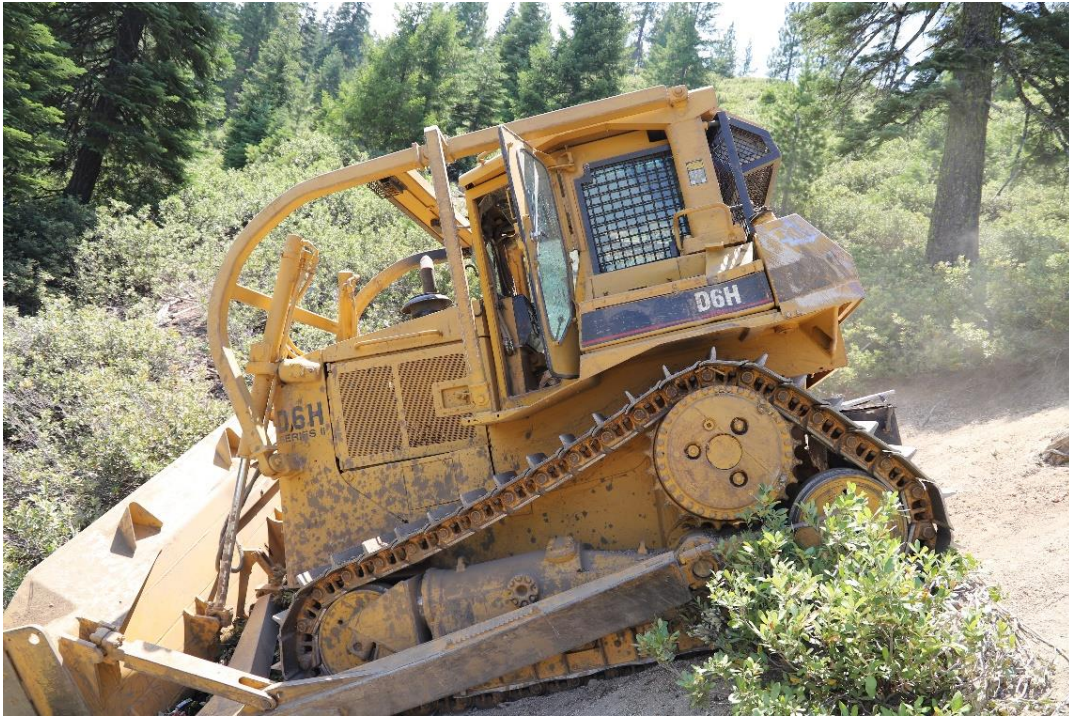
DOZ1, a 1995 Caterpillar D6H, exhibited moderate damage and was recovered under its own power. Inspection revealed the right blade lift cylinder was sheared off, blade tilt cylinder was sheared off at blade connection, right sweep mounting bolt sheared at rear of cab, the entire sweep assembly was pushed out of alignment, both rear idler pulley bearing pillow blocks out of alignment, air conditioning unit displaced, and the right Roll Over Protection upright slightly bent. A fire extinguisher mounted in the cab behind the operator's seat broke loose during the rollover and struck the front windshield breaking it. The side windows and front windshield were laminated preventing them from shattering. The right-side glass broke free of its mounting and landed next to the dozer. The laminated glass stayed intact protecting OP1 from additional intrusion of debris. The rear window glass was tempered and shattered during the event. A 30" LED light bar, mounted on the exterior behind a metal screen, along with the rear window frame was pushed into the cab area behind OP1's head. No other rollover damage was noted inside the cab area.

Left side of DOZ1

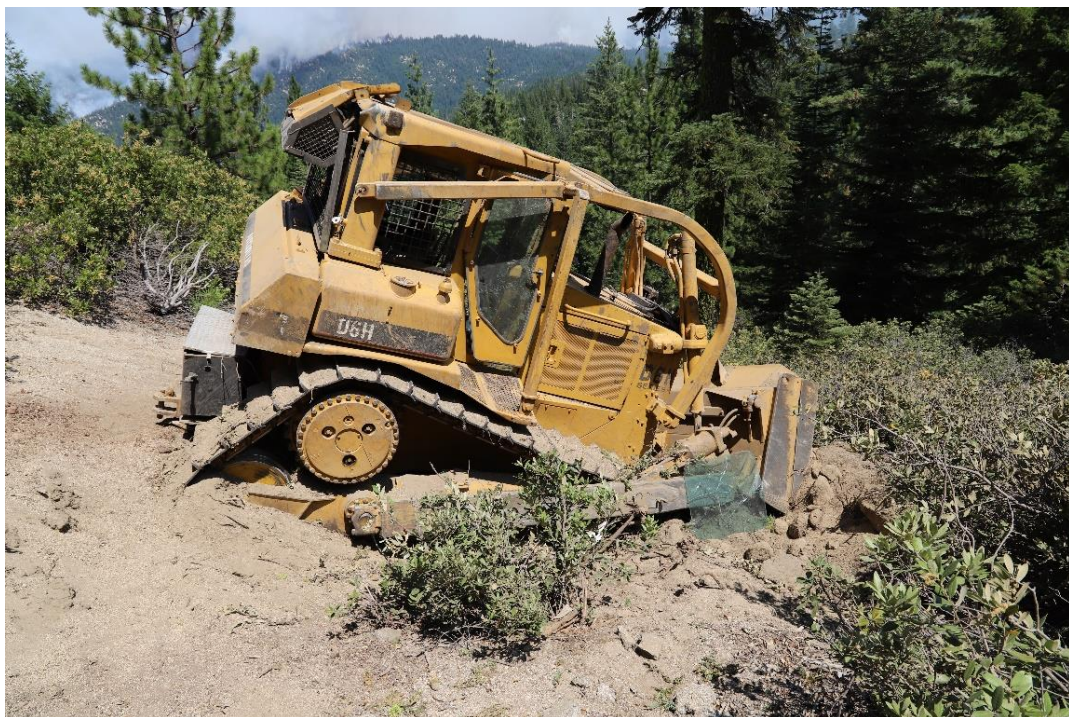
Right side of DOZ1
